**DESIGN, FABRICATION, AND TESTING
OF A COMPOSITE HULL
FOR A TRACKED AMPHIBIOUS VEHICLE**

Final Report
VOLUME I - TECHNICAL

Prepared Under Contract No. N00167-84-C-0024
for
David Taylor Research Center

FMC, Advanced Systems Center, 881 Martin Ave, Santa Clara, CA 95052

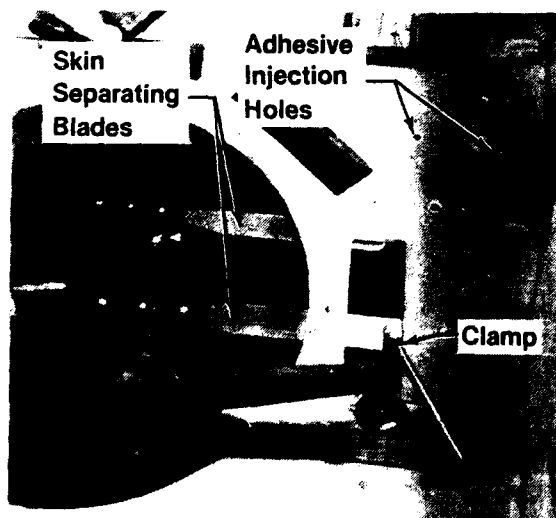
Figure 6-8. Upper Hull Skin Repair

We chose the Beta Mate 57/541-543 (Appendix A-29) because it was the only one of the group that produced 100% laminate failures (as opposed to bondline failures) when rebonded samples were tested in short beam shear. Techniques were developed and executed for the injection of adhesive and simultaneous clamping of areas where adhesive flow was not desired (i.e., the foam core areas). The only skin-to-skin contact areas that were not rebonded were areas adjacent to some hatch cutouts where bolts secured the final assembly. Figures 6-8 and 6-9 show the preparation for and injection of adhesive in the area of the driver's hatch.

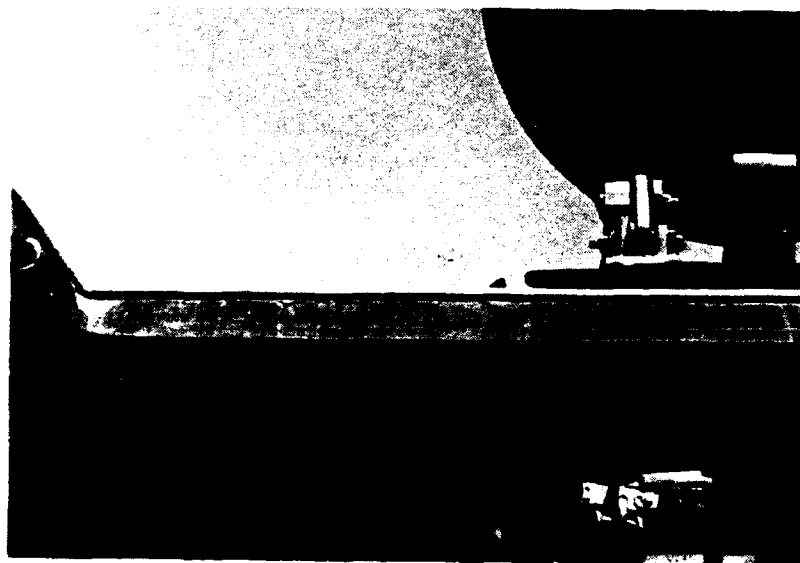
Figure 7-7. Trimmed Edge of Cargo Hatch Opening--No Visible Deterioration

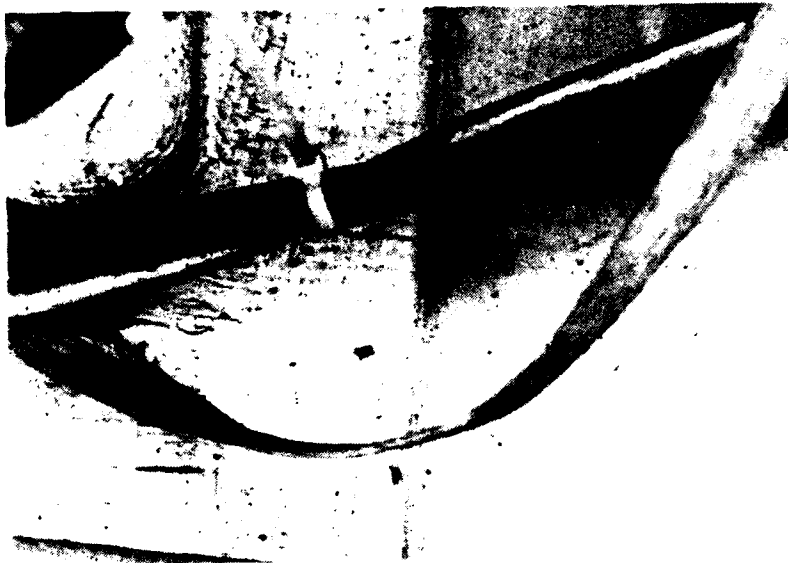
Figure 7-8. Roof Beam--Bond Shows No Degradation

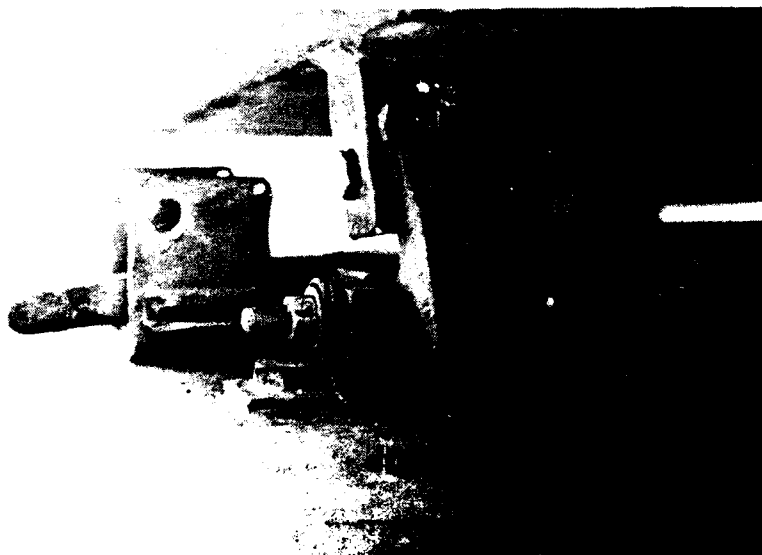
Figure 7-11. Mounting Hardware on Roof--Shows Signs of Hard Use But Remains Solidly Mounted
